STATEMENTS OF SIGNIFICANCE

Site Name: **CANADIAN PACIFIC RAILWAY STATION**

Date of Construction: 1906, addition to the south in 1911

Address: 402 North Railway Street

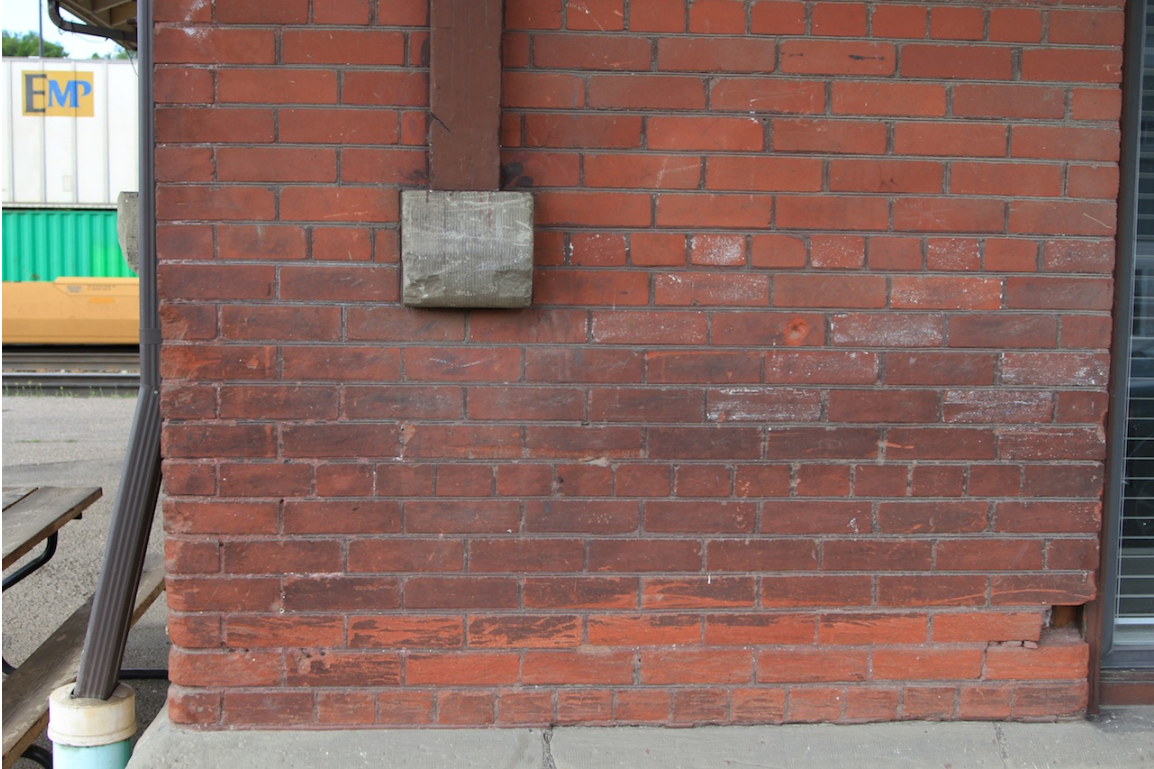
Mechanical wear on bricks from original portion of railway station (northwest side, facing tracks), June 2014 (Donald Luxton & Associates)

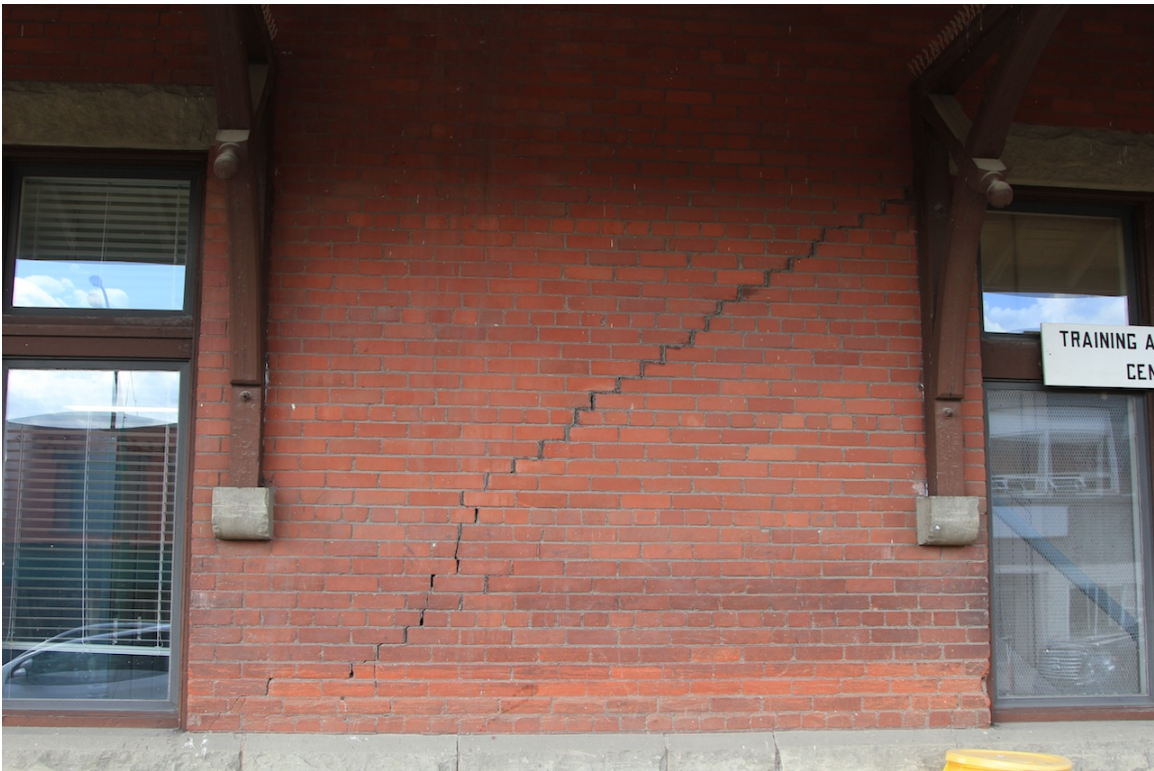
Cracking in mortar, west elevation of original building, June 2014 (Donald Luxton & Associates)

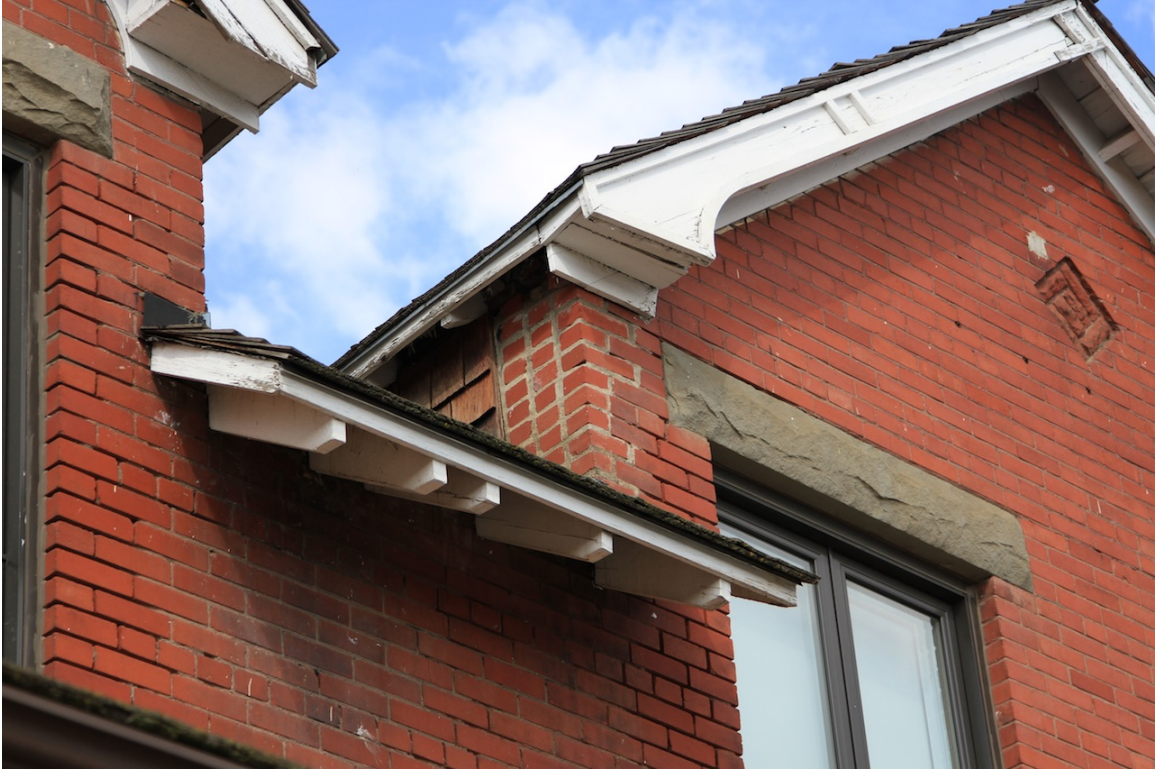
Mortar loss and past unsympathetic repointing on west elevation, June 2014 (Donald Luxton & Associates)
