Site Name: **MONARCH THEATRE**

Address: 609 – 613 2nd Street SE

Description of Historic Place

Statement of Integrity

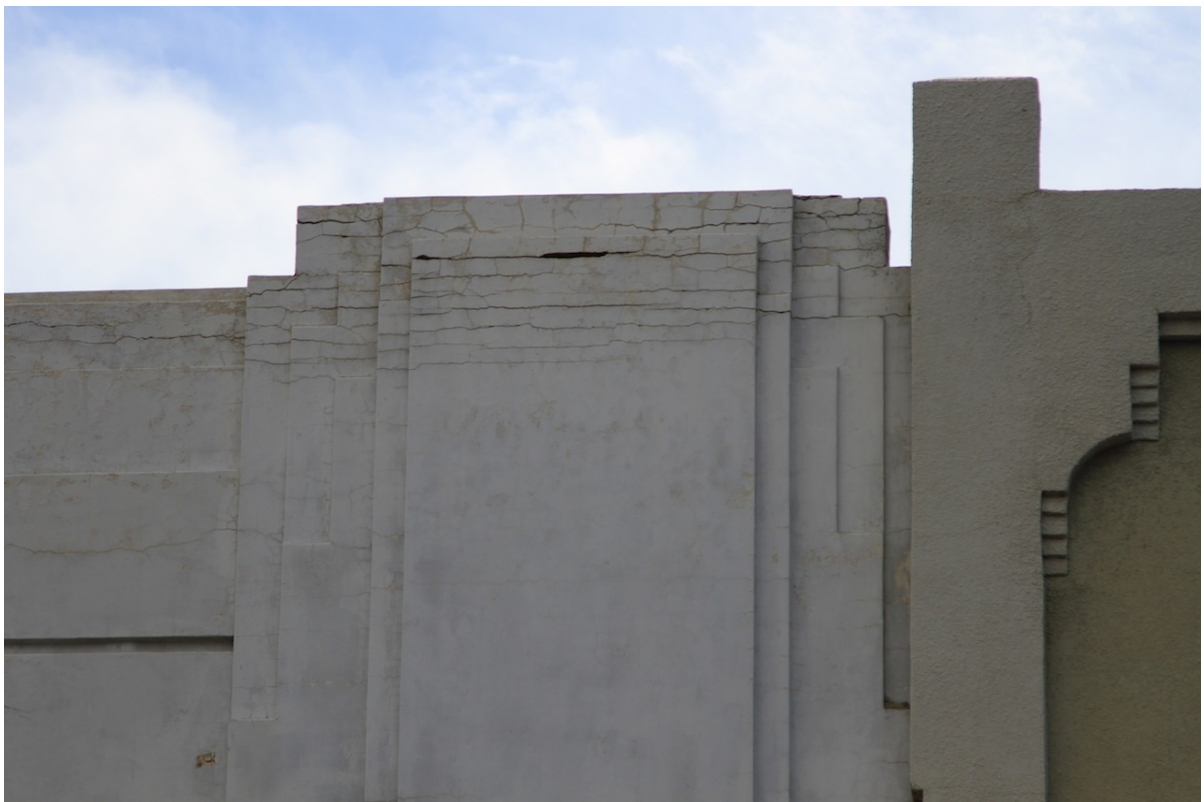
Monarch Theatre detail of vertical tower and damage to stucco cladding (Donald Luxton & Associates, 2014).

In 1940-1941, the east structural bay, formerly the cigar shop and pool hall, was renovated and the theatre expanded into the space with the cigar shop retained at the front of the building. The front façade of the bay was renovated to match the Streamline Moderne-style of the west structural bay. The 1941 storefront, with central entry and large windows on either side of the door, has been infilled, likely when the last tenant left in 1993. Following the infill, the storefront wall was covered in stucco of a coarser consistency then the original stucco and speed lines were extend across the east structural bay to mirror those present on the adjacent west structural bay. The stucco below the east structural bay speed lines has also been painted in contrast to the original stucco above. The stucco wall above the speed lines is in poor condition with numerous cracks radiating horizontally and vertically. The stucco on the speed lines also exhibits cracking and a vent has been installed in the lowermost speed line. The large centrally position window with reeded glass block is in situ and in good condition; however, the earlier detailing around the window has been painted over. The crenulated parapet has been retained and is in reasonable condition with some cracks present. The paint on the east structural bay above the speed lines has begun to fail.

Should the restoration and rehabilitation of the front façade by undertaken, the façade should be returned to its 1935 and 1940/1941 form.

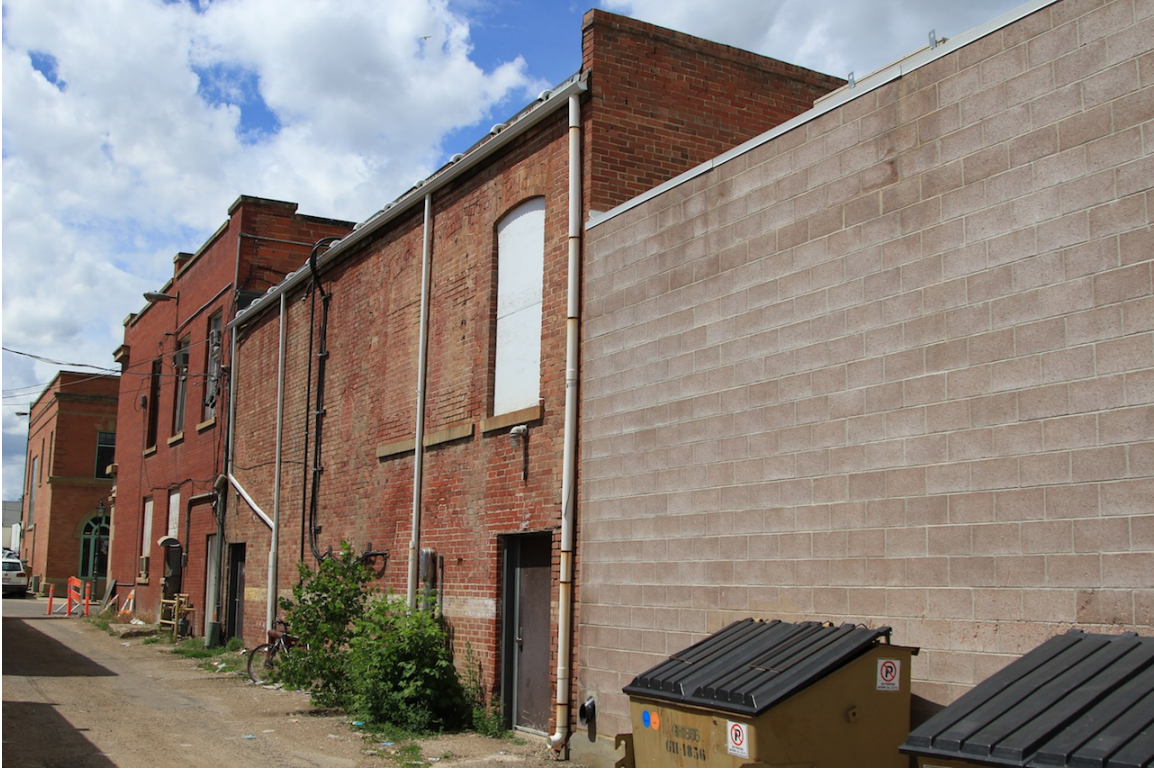
Monarch Theatre 1911 brick rear façade with enclosed segmental arched windows (enclosed post-1970s), which originally had 2-over-2 single-hung windows (Donald Luxton & Associates, 2014).

The rear façade of both structural bays is composed of red pressed brick in common bond with flat topped parapet at the east and west extents of the façade. The brick is in poor condition with significant areas of deterioration at the base of the wall, around penetrations (doors and conduits), and around gutters and rainwater leaders. The deterioration includes missing, cracked, and spalled brick, past unsympathetic repointing, and mortar loss,

<p>which is substantial in some areas due to water egress issues. The rear façade also possesses multiple stepped cracks, particularly near the top of the wall. Missing or significantly damaged brick should be replaced in-kind with compatible brick and the wall repointed to address mortar loss. The original wooden bargeboard is extensively damaged and sections are no longer anchored to the building. The soffits and brick wall show signs of repetitive water saturation, likely due to the configuration of the gutters. A more efficient roof drainage system should be installed to mitigate further deterioration of the brick façade. The existing rainwater leaders current outflow point is at the base of the wall and should be altered to carry rain and melt water further from the building's foundation. The brick parapet also exhibits mortar loss and asphalt sheeting has been installed on the inside face and over the top of the parapet. A number of original windows have been infilled since the building was constructed. Past conduit penetrations should be patched and redundant cables removed.</p> <p>Interior</p> <p>Aspects of the interior detailing, Art Deco design with Moorish accents, from the 1935 and 1940/1941 renovations are in situ and in good condition. The lobby is largely intact with box office still situated within the front vestibule. The lobby's curved walls, curved metal balustrades leading to the basement and box office, doors and hardware, and radiators are original and in good condition. The lobby has been altered with the installation of new flooring, a drop ceiling, light fixtures, concession stand, and code related elements. Portions of the original wooden floor, specifically in the corridor to the theatre, have been retained; however, the floor is heavily worn and requires restoration. The placement of a large projector in this corridor should be assessed as the floor has begun to bend due to the weight of the projector.</p> <p>The theatre is in good condition with aspects of its historic fabric intact. The original wooden floors have been covered in plywood and new seats installed. The curved staircase, with later enclosed curved metal balustrade, providing access to the women's powder room has been retained. The Art Deco wall sconces in the theatre have been removed, as has the wall curtains due to fire safety issues. The double swinging multi-light wooden doors on either side of the stage with decorative painted plaster above have been retained and are in good condition. The position of the stage position has not been altered and its original wood floor with trap doors to the basement is intact; but exhibiting signs of heavy wear. Behind the film screen is situated a swamp cooler used historically to cool the theatre during the summer months. The wooden framing supporting the swamp cooler and adjacent wooden elements exhibit signs of moisture damage and a complete assessment of all wooden framing should be undertaken to determine its present condition. Components of the theatre's 1940/1941 detailed plasterwork including column with ornamented capital are still evident behind the film screen. These components are in poor condition and efforts should be undertaken to preserve these unique and rare elements. The original lathe and plaster ceiling above the stage is also evident; however, large portions of the plaster are missing.</p> <p>The box office and women's powder room retain aspects of their 1935</p>

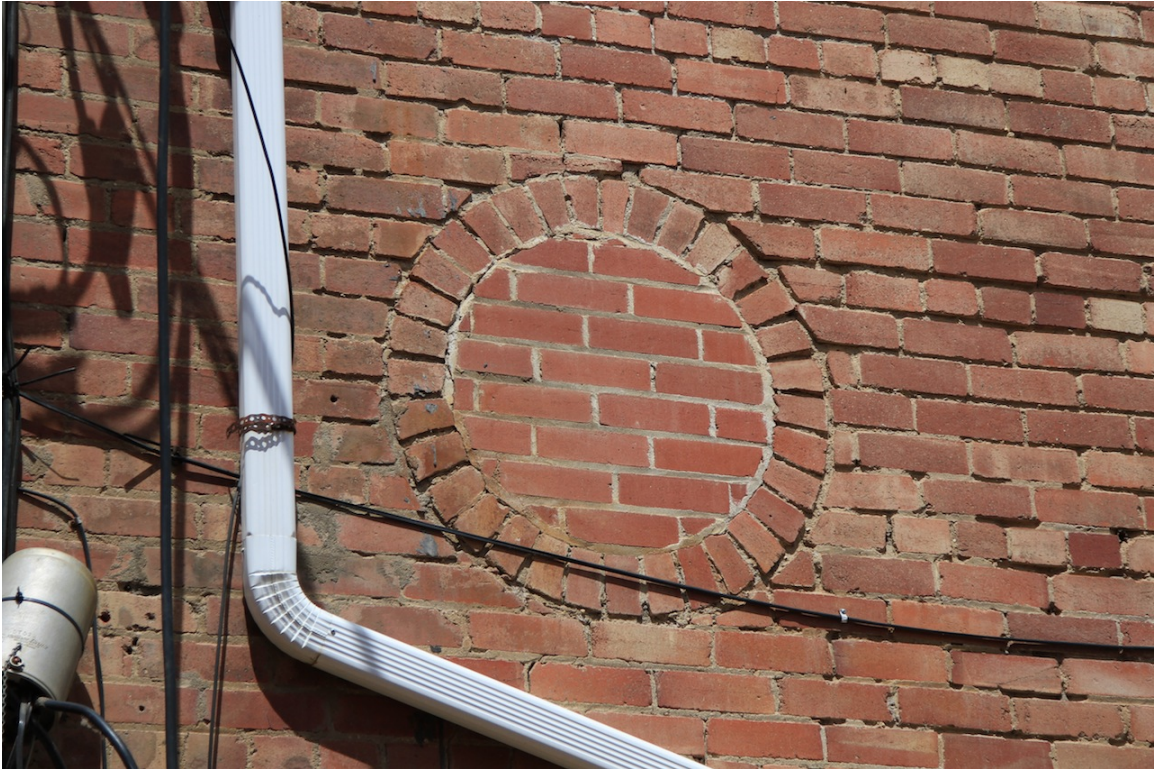
Monarch Theatre rear brick façade with infilled original circular window opening (enclosed post-1970s) (Donald Luxton & Associates, 2014).
