# STATEMENT OF SIGNIFICANCE

Site Name: HARGRAVE SISSONS BLOCK AND ANNEX

Date of Construction: 1901, 1909 (Annex) Address: 667, 669, and 675 2<sup>nd</sup> Street SE

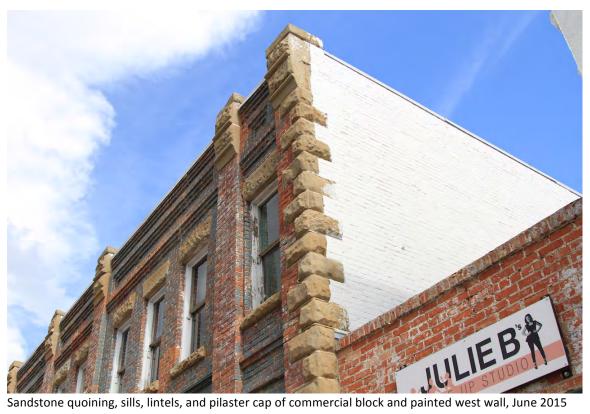
Sandstone quoining, sills, lintels, and pilaster cap of commercial block and painted west wall, June 2015 (DLA)

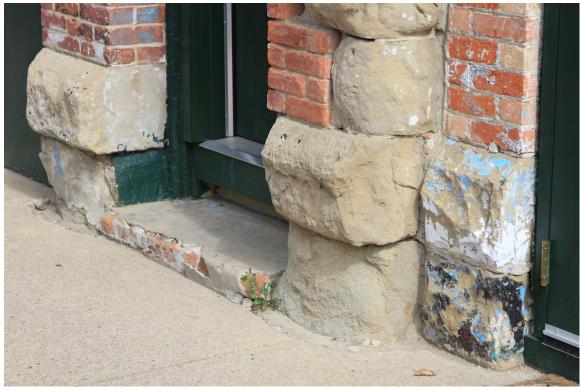
Deteriorated sandstone watertable with mortar loss, and damaged parging on brick stoop, June 2015 (DLA)

Coving typically due to wind, de-icing salts, mechanical damage, and moisture saturation has significantly deteriorated the sandstone base of the pilasters and watertable. A mason experienced in historic building should be engaged to determine the extent of the deterioration and if measures can be undertaken to stabilize and or rehabilitate the existing sandstone or if units require complete replacement. Localized mortar loss is also present which should also be assessed and rehabilitation is required repointing is completed using a mortar of similar strength, colour, and joint profile as the original. The entire masonry exterior of the building was painted first in the 1930s and repeatedly since then. In 2012 the paint was partially removed from the building with varying degrees of success. If further paint stripping is undertaken, the process chosen should not be damaging to the masonry or mortar and test patches should be preformed prior to proceeding with the work. The chamfered front entry and storefronts on both the east and north façades of the building have been altered since first constructed with the exception of the western most storefront on the north façade. The other storefronts reflect alterations made to the building in the 1930s. Overall, the arrangement of a transom above a full-height storefront has been maintained and is reflective of the original design of the block. The storefront is in good condition and appears to have been recently painted. There is no evidence of paint failure on the storefront. The chamfered corner entry is original to the building although the configuration of the door and sidelights has been changed. The original door at the time of the block was built was a double door with large upper glass panel and transom above. In the 1930s, likely when the main floor was split into multiple units, the double door was replaced with a single door with large glass panel, sidelights, and multilight transom, below the original transom. Presently, the existing door is a replacement, the sidelights have been covered, and the multi-light transom replaced with a single light. Originally, four steps were climbed to access the store. These steps have been removed, likely during the 1930s renovations. The entries to the second floor on the east and north façade appear to have retained their original configuration. The north façade is composed of a transom with single man door below with the extant door is a replacement. The east façade entry consists of two-stacked transoms with a single man door. The three panel wooden door with multi-light upper panel and hardware is of early form and may be original to the building. Parging on the brick stoops of the second floor entries is also failing and requires rehabilitation. The single assembly single-hung wooden-sash 1-over-1 windows on the second floor are original to the building. They are in varying degrees of deterioration and require rehabilitation. The original wooden-sash storm window have been are no longer present. Metal cap flashing has been installed on top of the parapet to prevent its deterioration and water penetrating between the wythes of brick.

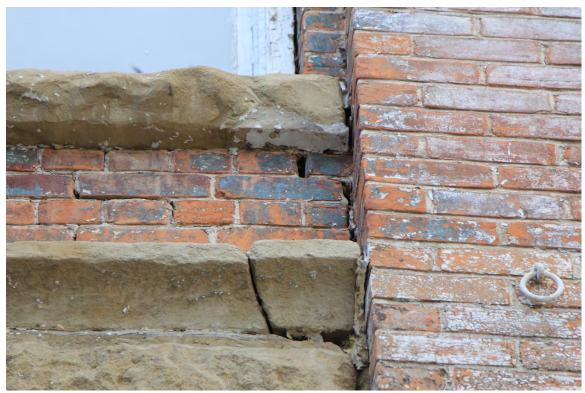
Cracked sandstone lintel, mortar loss, settlement issues at work, June 2015 (DLA)

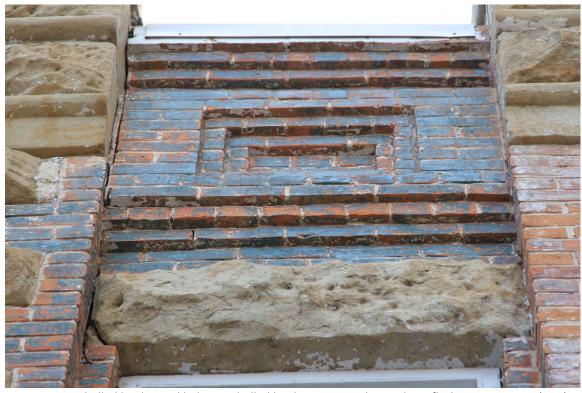
Decorative corbelled brick panel below corbelled brick parapet with metal cap flashing, June 2015 (DLA)

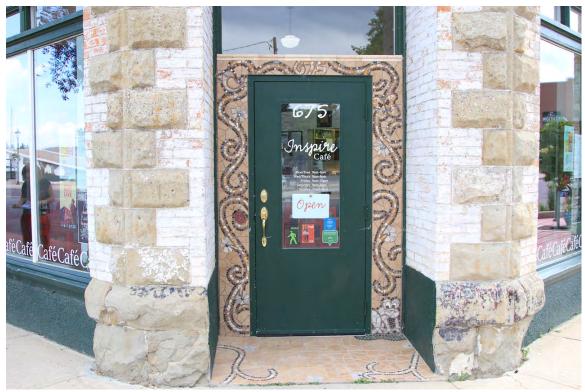
Chamfered entry with deteriorated sandstone watertable, replaced transom, covered sidelights, and replaced door, June 2015 (DLA).

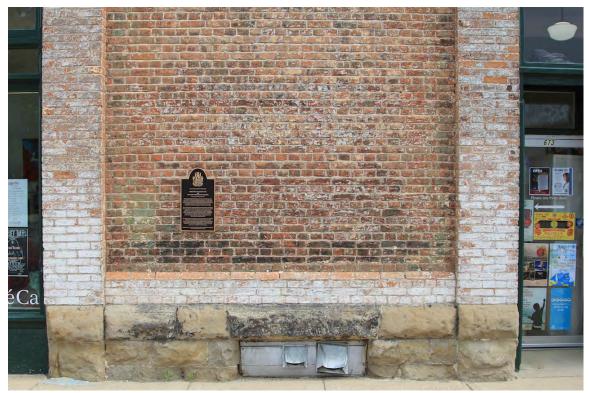
Brick façade with MHR plaque and showing both sandstone deterioration and results of paint removal from brick, June 2015 (DLA)
