Site Name: **MONARCH THEATRE**

Address: 609 – 613 2<sup>nd</sup> Street SE

### Statement of Integrity

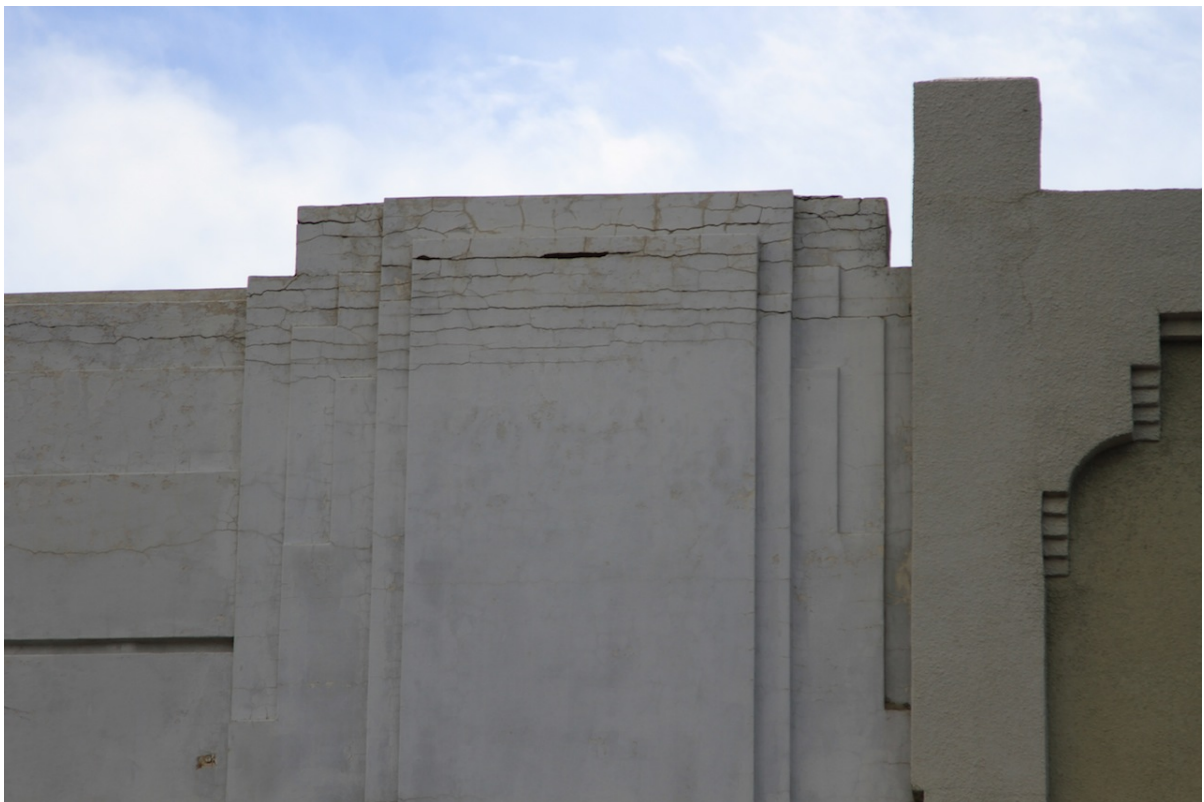
Monarch Theatre detail of vertical tower and damage to stucco cladding (Donald Luxton & Associates, 2014).

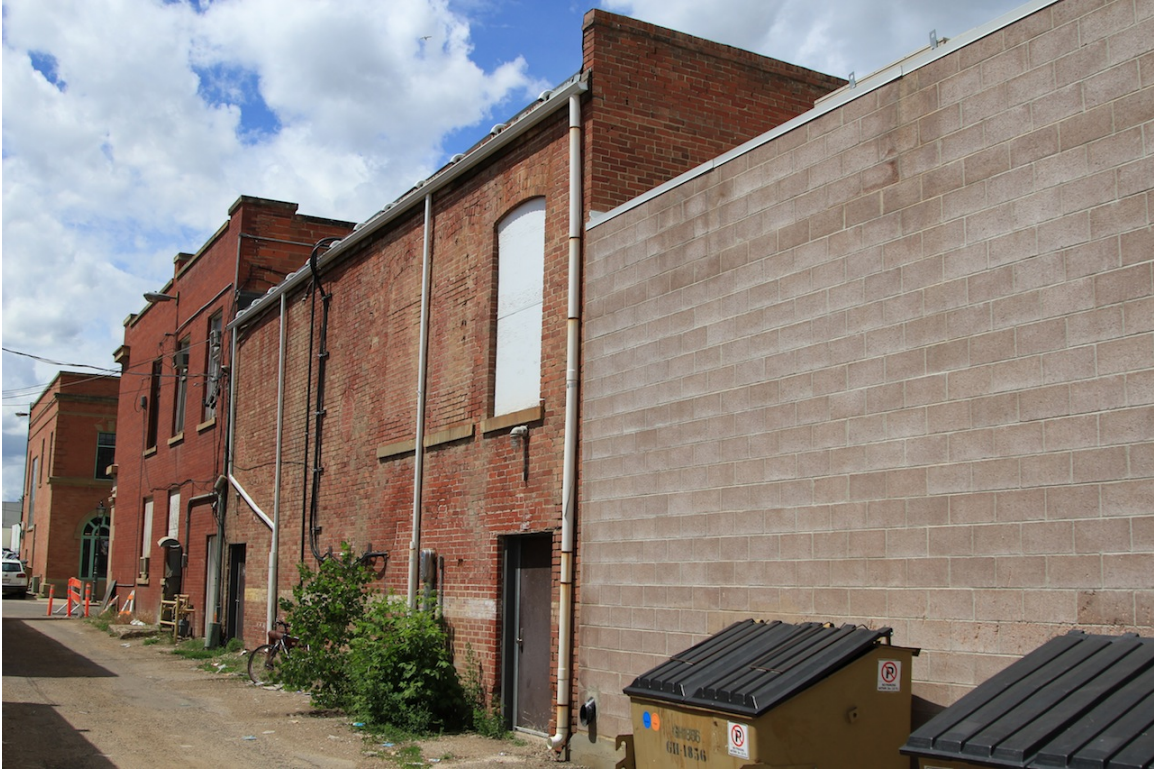
Monarch Theatre 1911 brick rear façade with enclosed segmental arched windows (enclosed post-1970s), which originally had 2-over-2 single-hung windows (Donald Luxton & Associates, 2014).

| | <p>poster display cabinets, on the either side of the front entry, has been maintained. The three single panel doors with single light glass insert that provide access to the theatre's lobby, are original to the 1935 renovation and have retained their original hardware on the interior. The theatre's marquee has been altered from the time it was installed in 1935. The marquee's form and placement has been maintained; however, the soffits, which originally contained multiple rows of exposed light bulbs, has been replaced with metal soffits with recessed lighting. The entire marquee, including the stepped wing walls on the top of the marquee, has been encapsulated in metal cladding and the 1935 neon tubing was removed. In 1956, a large readograph sign was installed above the original marquee perpendicular to the front façade of the west structural bay. The sign has since been removed; however, the footprint of the sign is still visible and the stucco wall should be restored. The original "Monarch" signage on the front of the marquee has been replaced with a box sign. An additional illuminated box sign has been installed perpendicular to the front façade on the eastern vertical tower. The original 8-over-8 wooden-sash single-hung window, centrally positioned above the marquee, has been removed and a partial door and stair installed to provide access to the top of the marquee.</p> <p><b>Exterior – East Structural Bay</b></p> <p>In 1940-1941, the east structural bay, formerly the cigar shop and pool hall, was renovated and the theatre expanded into the space with the cigar shop retained at the front of the building. The front façade of the bay was renovated to match the Streamline Moderne-style of the west structural bay. The 1941 storefront, with central entry and large windows on either side of the door, has been infilled, likely when the last tenant left in 1993. Following the infill, the storefront wall was covered in stucco of a coarser consistency then the original stucco and speed lines were extend across the east structural bay to mirror those present on the adjacent west structural bay. The stucco below the east structural bay speed lines has also been painted in contrast to the original stucco above. The stucco wall above the speed lines is in poor condition with numerous cracks radiating horizontally and vertically. The stucco on the speed lines also exhibits cracking and a vent has been installed in the lowermost speed line. The large centrally position window with reeded glass block is in situ and in good condition; however, the earlier detailing around the window has been painted over. The crenulated parapet has been retained and is in reasonable condition with some cracks present. The paint on the east structural bay above the speed lines has begun to fail.</p> <p>Should the restoration and rehabilitation of the front façade by undertaken, the façade should be returned to its 1935 and 1940/1941 form.</p> <p><b>Rear Façade – West and East Structural Bay</b></p> <p>The rear façade of both structural bays is composed of red pressed brick in common bond with flat topped parapet at the east and west extents of the façade. The brick is in poor condition with significant areas of deterioration at the base of the wall, around penetrations (doors and conduits), and around gutters and rainwater leaders. The deterioration includes missing, cracked, and spalled brick, past unsympathetic repointing, and mortar loss,</p> |

| | <p>which is substantial in some areas due to water egress issues. The rear façade also possesses multiple stepped cracks, particularly near the top of the wall. Missing or significantly damaged brick should be replaced in-kind with compatible brick and the wall repointed to address mortar loss. The original wooden bargeboard is extensively damaged and sections are no longer anchored to the building. The soffits and brick wall show signs of repetitive water saturation, likely due to the configuration of the gutters. A more efficient roof drainage system should be installed to mitigate further deterioration of the brick façade. The existing rainwater leaders current outflow point is at the base of the wall and should be altered to carry rain and melt water further from the building's foundation. The brick parapet also exhibits mortar loss and asphalt sheeting has been installed on the inside face and over the top of the parapet. A number of original windows have been infilled since the building was constructed. Past conduit penetrations should be patched and redundant cables removed.</p> <p><b>Interior</b></p> <p>Aspects of the interior detailing, Art Deco design with Moorish accents, from the 1935 and 1940/1941 renovations are in situ and in good condition. The lobby is largely intact with box office still situated within the front vestibule. The lobby's curved walls, curved metal balustrades leading to the basement and box office, doors and hardware, and radiators are original and in good condition. The lobby has been altered with the installation of new flooring, a drop ceiling, light fixtures, concession stand, and code related elements. Portions of the original wooden floor, specifically in the corridor to the theatre, have been retained; however, the floor is heavily worn and requires restoration. The placement of a large projector in this corridor should be assessed as the floor has begun to bend due to the weight of the projector.</p> <p>The theatre is in good condition with aspects of its historic fabric intact. The original wooden floors have been covered in plywood and new seats installed. The curved staircase, with later enclosed curved metal balustrade, providing access to the women's powder room has been retained. The Art Deco wall sconces in the theatre have been removed, as has the wall curtains due to fire safety issues. The double swinging multi-light wooden doors on either side of the stage with decorative painted plaster above have been retained and are in good condition. The position of the stage position has not been altered and its original wood floor with trap doors to the basement is intact; but exhibiting signs of heavy wear. Behind the film screen is situated a swamp cooler used historically to cool the theatre during the summer months. The wooden framing supporting the swamp cooler and adjacent wooden elements exhibit signs of moisture damage and a complete assessment of all wooden framing should be undertaken to determine its present condition. Components of the theatre's 1940/1941 detailed plasterwork including column with ornamented capital are still evident behind the film screen. These components are in poor condition and efforts should be undertaken to preserve these unique and rare elements. The original lathe and plaster ceiling above the stage is also evident; however, large portions of the plaster are missing.</p> <p>The box office and women's powder room retain aspects of their 1935</p> |

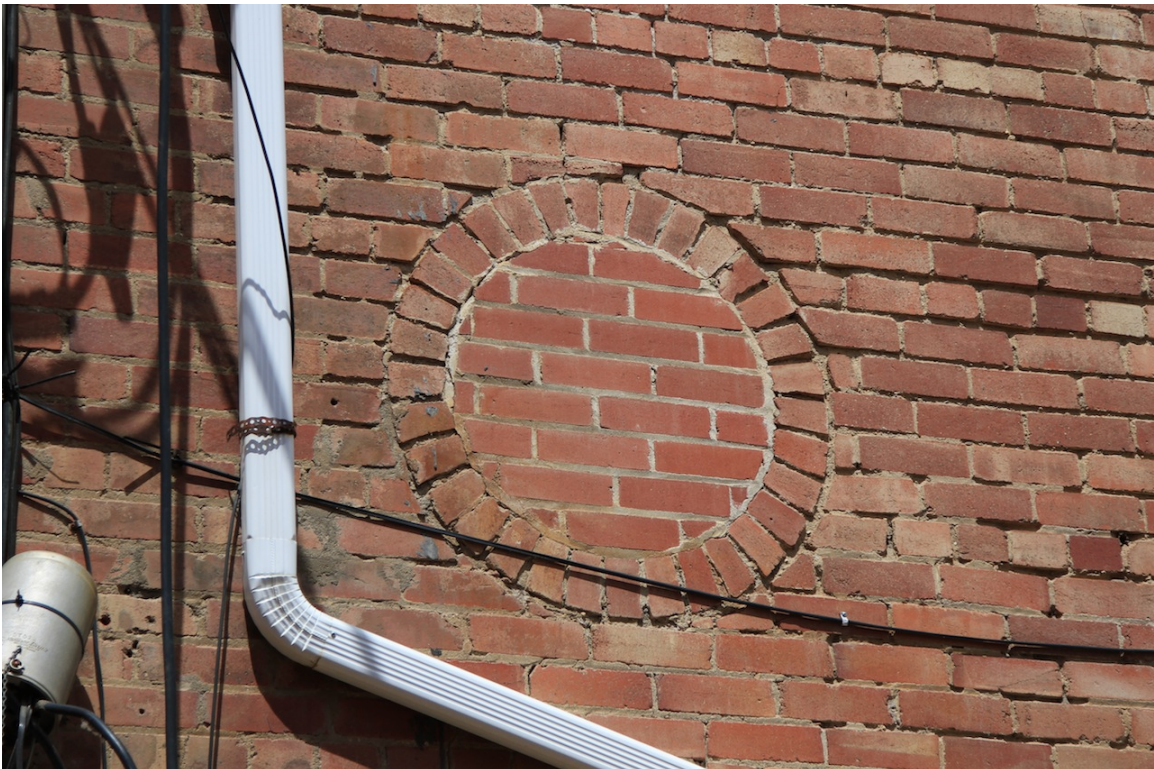
Monarch Theatre rear brick façade with infilled original circular window opening (enclosed post-1970s) (Donald Luxton & Associates, 2014).
