Donald Luxton & Associates June 2013

Character-Defining Elements - Marshall Terrace (526-540 - 6 Avenue SE)

Statement of Integrity - Marshall Terrace (526-540 - 6 Avenue SE)

Heritage Evaluation Form - Marshall Terrace (526-540 - 6 Avenue SE)

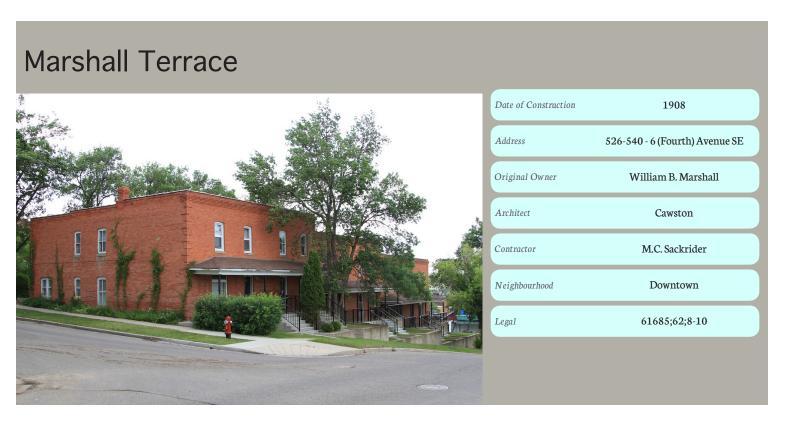
Marshall Terrace is housing units located over three sloped lots at the northwest corner of the intersection of 6th Avenue SE and Aberdeen Street SE, south of Medicine Hat's downtown core. The six units of the terrace housing are grouped in pairs, with each grouping slightly stepped-down from the one that it abuts to the south. The red brick exterior is accented with corner quoining and a corbelled brick cornice. Each grouping of units possesses a hippedroof verandah, separate entry, and stair. The building is set back from the street and fronted with small, grassed yards retained by stamped concrete terraces and mature trees and shrubs.

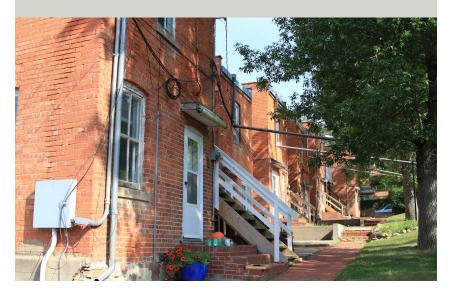
Rear of Marshall Terrace showing the multiple recessed courtyards

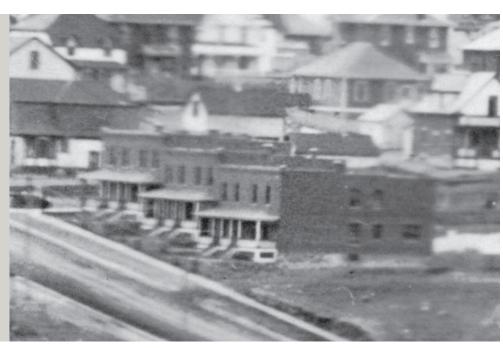
Esplanade Archives, Medicine Hat, Alberta 0514 0001b

Detail from a 1913 panorama of Medicine Hat showing Marshall Terrace
