# Montgomerie Apartments

## Character-Defining Elements - Montgomerie Apartments (621 - 5 Street SE)

## Statement of Integrity - Montgomerie Apartments (621 - 5 Street SE)

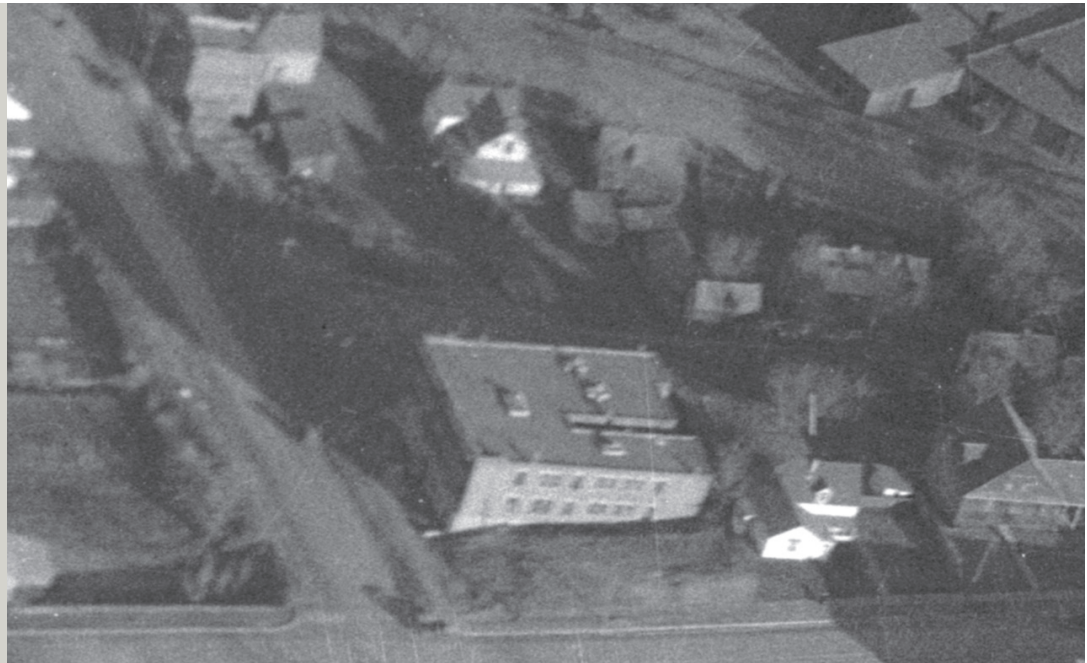
Aerial view of Montgomerie Apartments, centre, from circa 1946. A small section of the CPR roundhouse can see at the top-left

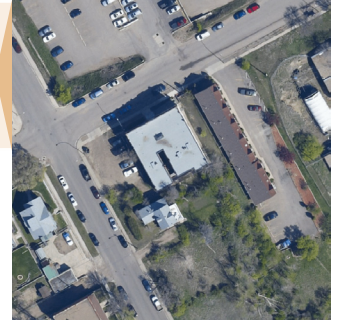
- Landscape elements such as mature trees at the rear of the lot and terraced beds at the front façade

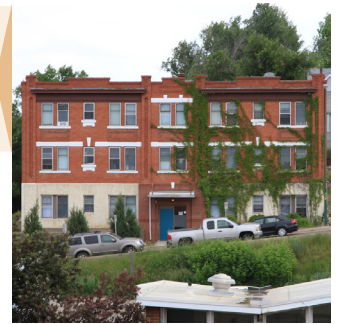
- Masonry construction including: concrete foundation; stretcher pattern pressed red brick exterior with tooled grey mortar on the front façade and plain mortar on the rear façade

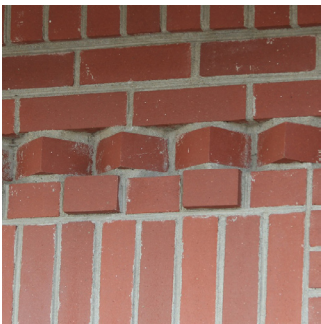
- Classical Edwardian-style details such as: balanced plan; regular fenestration; entry canopy with iron braces; corner quoining; pressed tin cornice with dentils; keystones; horizontal banding; corbelled brick chimneys

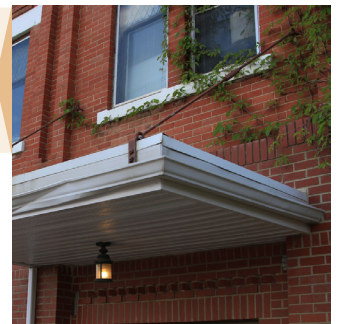
- Gothic Collegiate-style details including: multiple parapets; fluted pilasters projecting above the roofline; decorative relief brickwork

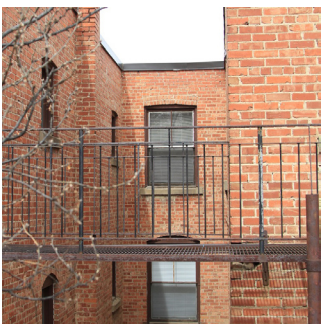
- Fenestration such as: single and double assembly 1-over-1 single-hung wooden-sash windows with diamond patterned leaded upper sash; segmental arch single assembly 2-over-1 single-hung wooden-sash windows; single and double assembly 1-over-1 single-hung wooden-sash windows; fixed single light wooden-sash windows; parged sills and lintels throughout; hipped-roof skylight with vent; transom over exterior rear doors

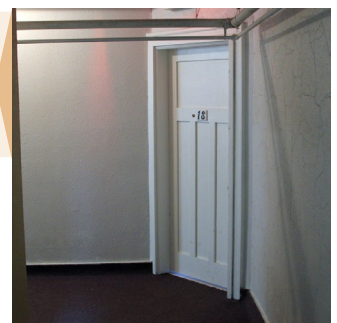
- Interior features such as: newel post; closed balustrade; cast iron radiators; wooden trim

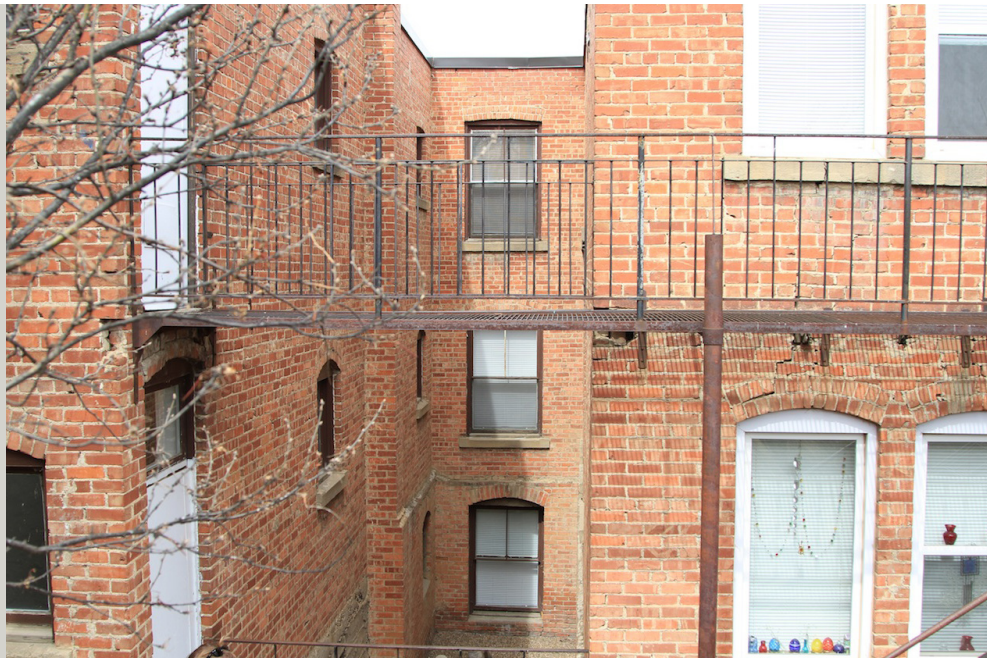
Rear of Montgomerie Apartments showing the iron gangway
