STATEMENT OF SIGNIFICANCE

Site Name: MERCHANTS BANK OF CANADA

Date of Construction: 1899 Address: 657-659 2nd Street SE

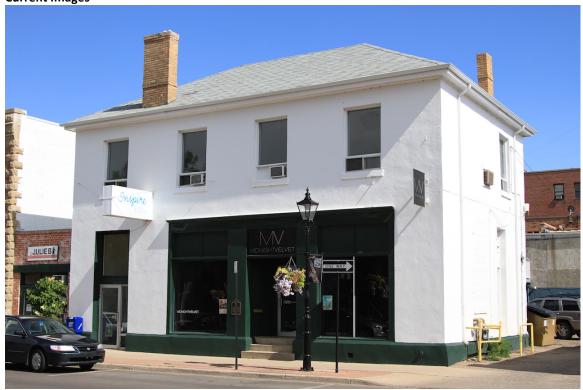
Stucco clad north and east façades and later added storefront on north façade, June 2015 (DLA)

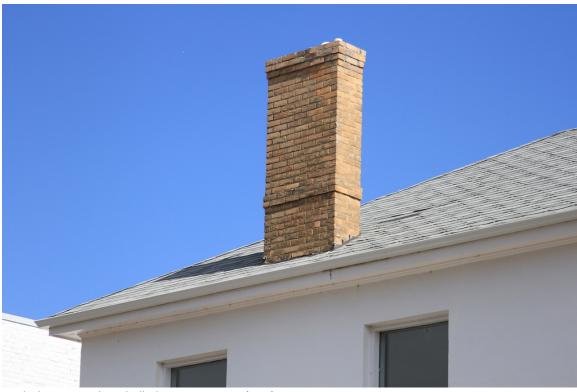
Brick chimney with corbelled cap, June 2015 (DLA)

| | Materials ☑ Yes □ No □ Not Applicable |
|---|--|
| | asphalt shingles and requires replacement. Gutters and rainwater leaders are present and anchored to the building. The internal brick chimneys are |
| | in good condition with no evidence of leaning or settlement. There is |
| | localized mortar loss on both the chimney, which should be monitored and |

| | Materials ☑ Yes □ No □ Not Applicable |
|---|--|
| | action taken if the rate of loss increase substantially. The original wooden |

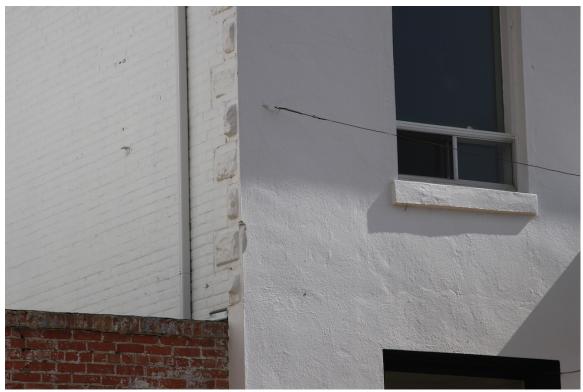
Original brick exterior with sandstone quoining and later applied stucco, June 2015 (DLA)

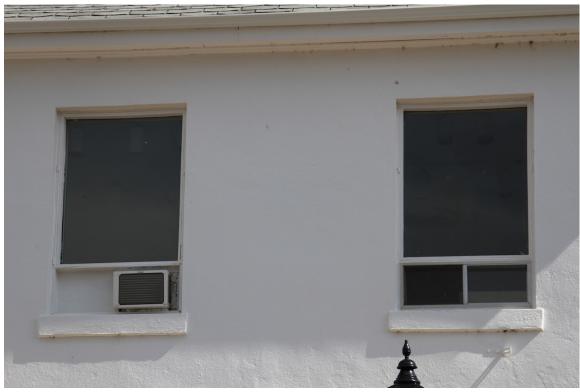
Rectangular window openings with parged stone sills on second storey, windows replaced, June 2015 (DLA)

| | Materials ☑ Yes □ No □ Not Applicable |
|---|--|
| | fenestration openings on the second floor have been maintained; |
| | however, the original wooden-sash windows have been replaced. The |

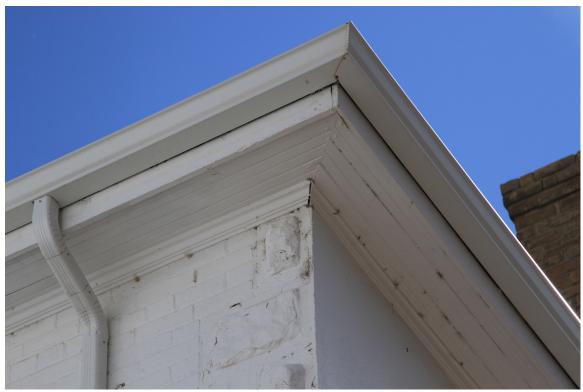
Wooden tongue and groove soffit with cornice board, June 2015 (DLA)

| | Materials ☑ Yes □ No □ Not Applicable |
|---|--|
| | soffit is intact and has been partially painted. Two of the most significant |

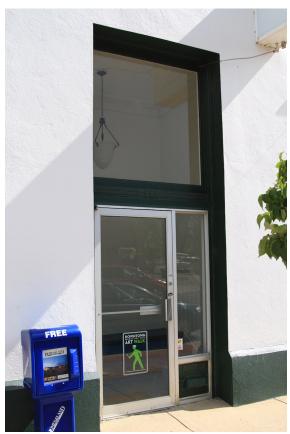
Original entry with intact wooden-sash single light transom, June 2015 (DLA)

| | Materials ☑ Yes □ No □ Not Applicable |
|---|--|
| | original entries on the north (furthest east) and west façades have been |
| | maintained. The transom above the original entry on the north façade is |
| | intact; however, the door and sidelight are replacements. The five-panel |

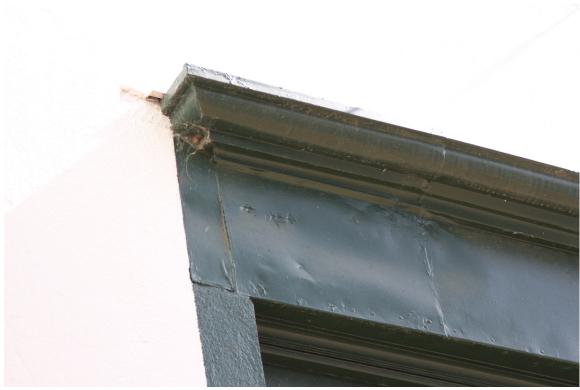
Tin cornice above storefront, June 2015 (DLA)

| | Materials ☑ Yes □ No □ Not Applicable |
|---|--|
| | The full-height storefront with transom, recessed entry, and tin cornice is |
| | also in good condition and appears to have been recently painted |

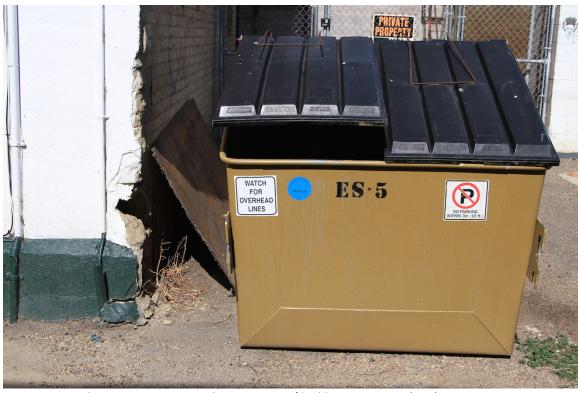
Damage to sandstone quoining at southwest corner of building, June 2015 (DLA)

| | Materials ☑ Yes □ No □ Not Applicable |
|---|--|
| | The stucco is in good condition with no evidence of cracks; however the |
| | southwest corner has multiple areas of damage, possibly from the |
| | emptying of the adjacent trash bin, to the stucco and sandstone quoining. |

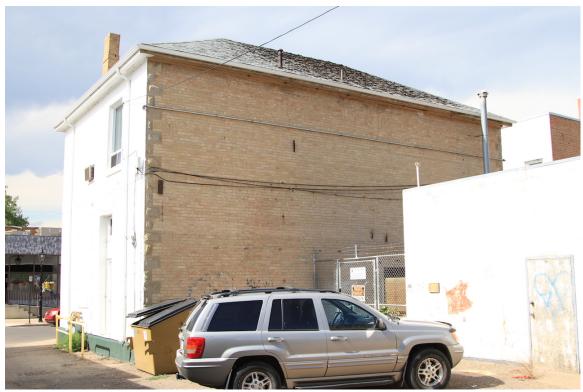
Original exterior at rear of building showing original finish, June 2015 (DLA)

| | Materials ☑ Yes □ No □ Not Applicable |
|---|--|
| | evident on the east and south façades, appears to be in good condition |
| | with localized mortar loss. Graffiti in present on the rear of the building, |
| | with evidence of past attempts to remove graffiti also apparent. The |

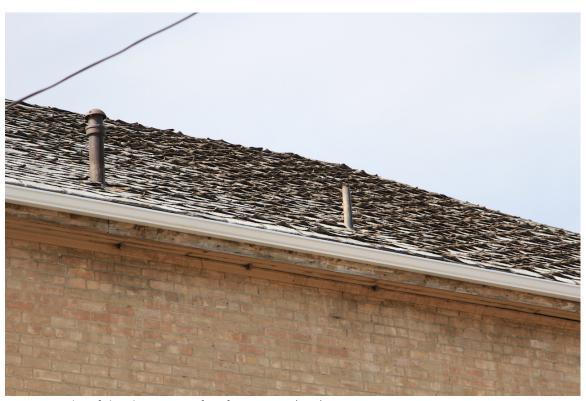
Deteriorated roof shingles on rear of roof, June 2015 (DLA)

| | Materials ☑ Yes □ No □ Not Applicable |
|---|--|
| | roof on the front of the building appears to be in good condition. The roof |
| | on the rear of the building is heavily deteriorated with cracked and curled |
